## The Role of Computed Tomography in the Diagnosis of Spinal Injuries

## Abdulhakimov. Sh. A

Bukhara State Medical Institute

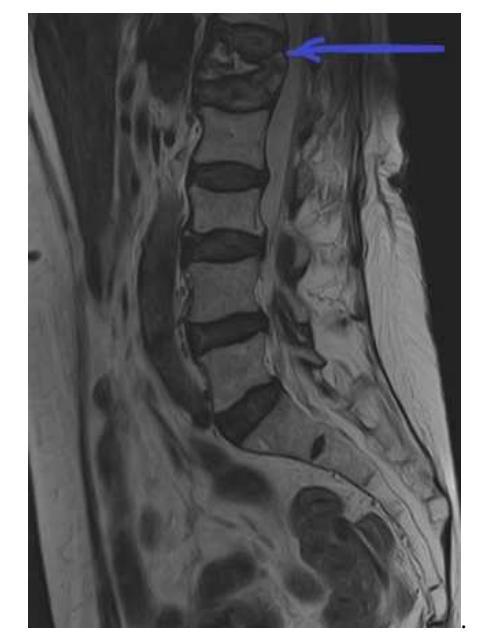
MRI of the lumbosacral spine. On the T2-VI in the sagittal plane, a compression fracture of the L1 vertebra is determined against the background of osteoporosis.

- KT complicated fractures of the spine In cases when there is doubt about the interpretation of the research, when the clinical picture does not match the existing x-ray and CT picture, if you need to visualize the spinal cord appropriate MRI MRI scan allows you to see magadane structure of the spine ligaments, intervertebral discs, covers the spinal cord and the spinal cord itself with its changes (ischemia - edema, hemorrhage, cyst), extra - and intradural hemorrhage, as well as changes in the vertebral bodies. If the patient has compression radicular or myeloradicular symptoms, or if there is no bone pathology on X-rays, MRscans may reveal a herniated disc. An accurate diagnosis of the level and nature of damage allows for minimally invasive surgical intervention [1,7,9,10]. (Fig. 1)
